CASE STUDY

# COMMUNITY IN A CUBE RIVERSIDE ONE

## **80 residential units, mixed-use development**

## **Evaluation Team**

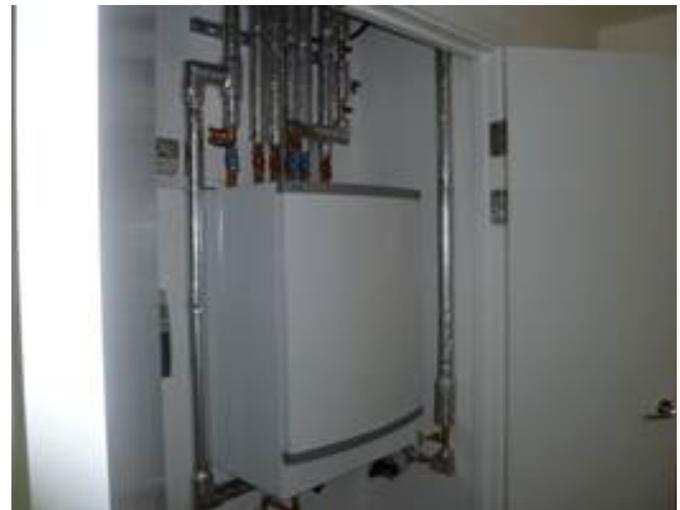
Communal heating system - heat exchanger unit

- No commissioning information was provided for the heat exchanger unit within the apartment.
- The majority of the pipework within the test apartment was well insulated, with the exception of missing insulation over isolation valves and at drain-off points.
- Insulation on communal pipework located outside the test apartment was not always continuous, particularly at isolation valves.
- The temperature within the cupboard that houses the heat exchangers was very warm despite the fact that the heat exchanger had been isolated and there was no call for heat.
- Communal corridors were noticeably 'warm' on cold days, even though no source of space heating was provided to these areas and the lighting had not been activated.

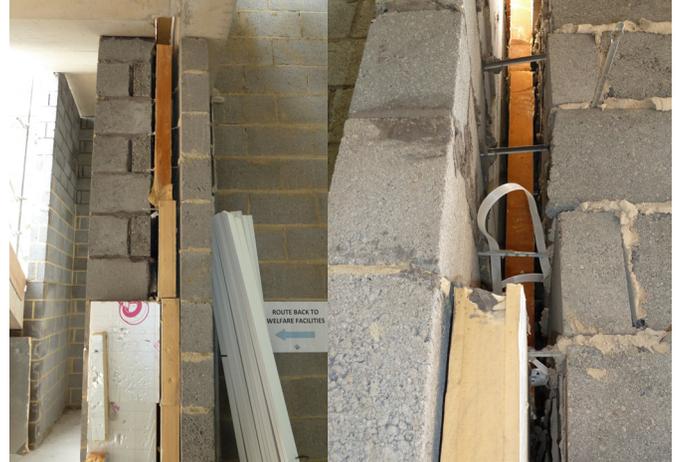
Unsecured partial fill insulation at ground floor

- The partial fill insulation was not securely retained against the inner face of the blockwork at ground floor level, with retaining clips for insulation missing. This could cause a thermal bypass to form between the insulation and the inner leaf of blockwork.

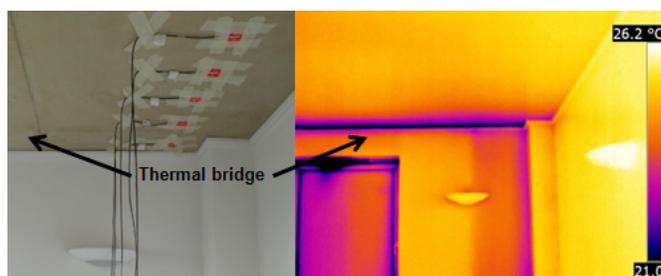
Thermal bridge into communal area

- The windows were ineffectively sealed, resulting heat loss due to air infiltration.
- Cold air infiltration was observed through closed trickle vents in the windows in the test apartment. These vents were supposed to be permanently sealed by the contractor.
- Heat gains were coming from the communal heating heat exchanger unit, and the uninsulated communal heat main pipework was transferring heat to the hallway and bedroom.
- Heat transfer between apartments was occurring through the uninsulated party floors.
- The concrete frame of the building was acting as a conduit for heat transfer throughout the superstructure.

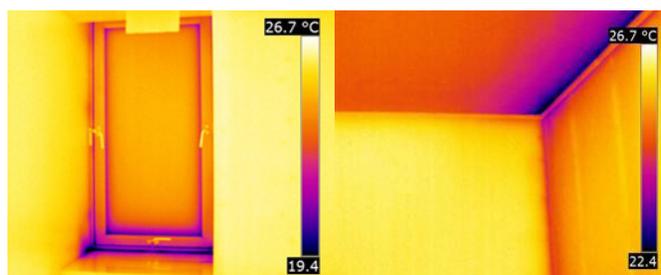
Heat loss at base of window (L); Thermal bridge along external wall edge (R)

- Thermal bridging was occurring at the junc-

tion between floor and external wall.

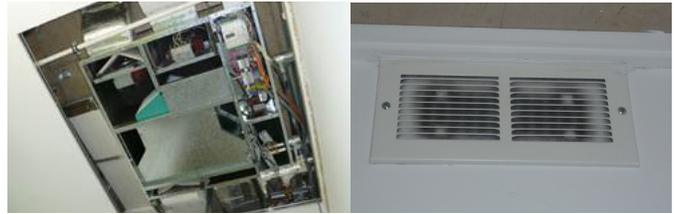
MVHR unit and wall-mounted diffuser with filter

- The supply air diffusers incorporate a thin filter which can only be accessed by unscrewing the grille from the wall. The purpose of these filters is not known - the MVHR unit also contains supply and extract filters. A borescopic examination of a small area of supply and extract ductwork showed a significant build-up of particulates on the filter of the supply diffuser to the bedroom and inside of the ductwork. Although the apartment had not been occupied, the MVHR had been left running, and these particulates likely accumulated during construction.

- The supply diffusers in the bedroom and living/kitchen area are located directly above the doors. There is a risk that these rooms will be inadequately ventilated as the type of diffuser used is not capable of supplying air deep into these rooms.

- The extract air grilles (which are the same as fitted for supply air) have been crudely taped onto the end of the rectangular extract ductwork. Access to these grilles is through small hatches in the plasterboard ceiling. However this access provides very little working room, making it difficult to

- The main filters within the MVHR unit casing (installed in the bathroom ceiling void) cannot be easily changed or cleaned as they can only be accessed by unscrewing the base plate from the unit. Further, there is also no filter change, maintenance or service indicator light on the unit. Due to the difficult filter access, it is unlikely that the occupants would change the MVHR system filters themselves. However, the maintenance team at CIAC is currently responsible for replacing the MVHR filters on a yearly basis.
- The condensate from the MVHR unit ran upwards, away from the unit, which will likely result in a build-up of condensate within the pipework and possibly within the unit itself.
