CASE STUDY

RACECOURSE

Building Performance Evaluation

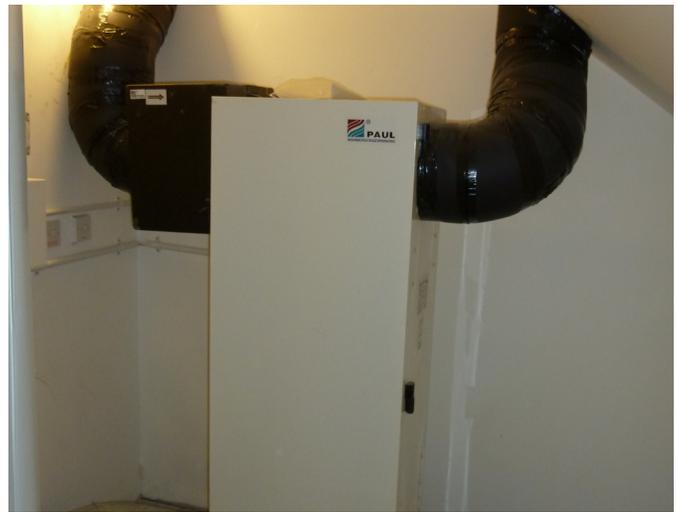
MVHR installation

- Locating the plant space on the mezzanine floor is not the preferred option for building maintenance, for example, changing filters in the MVHR system.

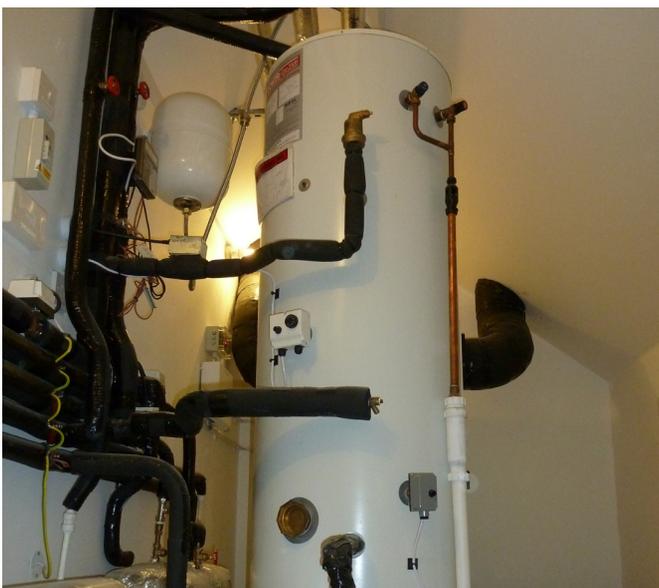
Domestic hot water cylinder

- In both dwellings the drain cocks were not at the lowest points in the system.
- The pressure in the expansion vessel was too high in Dwelling 1.
- In Dwelling 2 there was an error light on the control system, a panel sensor was damaged, fluid circulation could not be tested due to the sensor error, and the system and expansion vessel pressure were both too high.

Remedial works were subsequently undertaken to reduce the pressure in the expansion vessels and system and replace/repair the sensor connections.

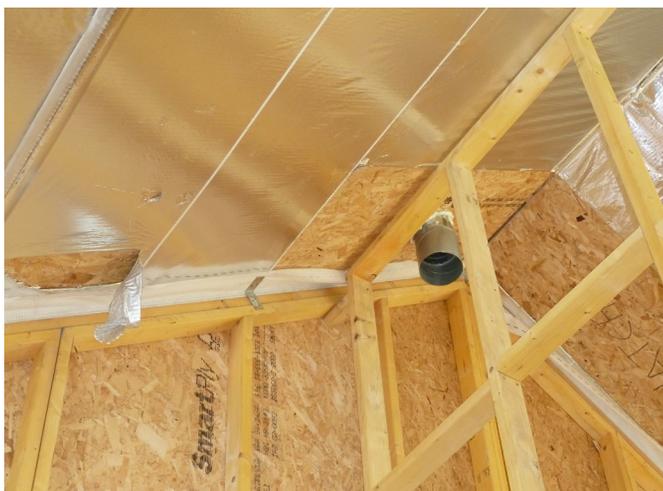
Air barrier membrane with tear

site manager confirmed that the membrane was fragile and susceptible to repeated damage. Resource had to be dedicated to fixing tears in the air barrier membrane to avoid air leakage points.

noted that the contractor had paid close attention to taping-up damaged areas of air barrier membrane. The contractor had also ensured continuity of the air barrier membrane around openings, such as windows.

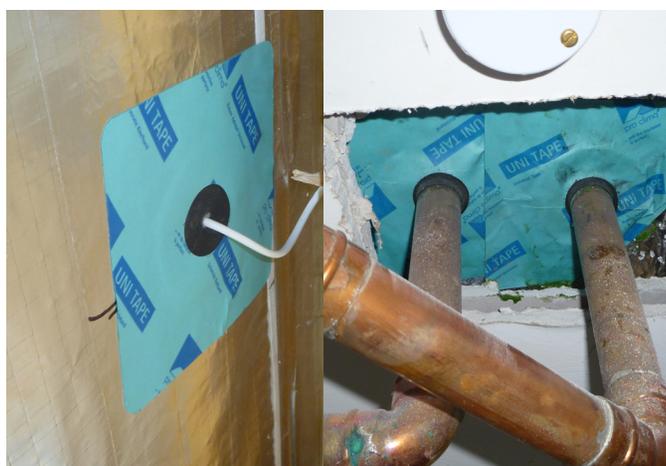
Sealed services penetrations

- The contractor had taken care to use the appropriate gaskets, grommets and sealing putty to seal any services that penetrated through the air barrier membrane. However, no attempt had been made to seal where some services penetrated the external layer of bitroc on the outside wall, which

may result in wind washing.
