# **GHA Monitoring Programme 2011-13: Technical Report**

Results from Phase 2: Post-  
occupation testing of a sample of  
sustainable new homes

May 2014

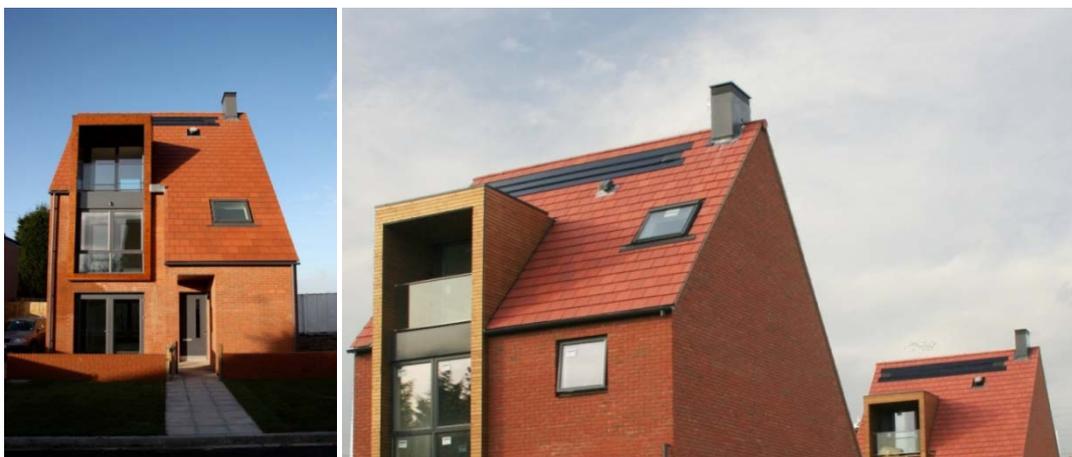
Figure 1. Derwenthorpe prototype homes

House A was constructed using a **Structural Insulated Panel (SIPs)** build system. House B was constructed using **thin joint masonry** construction. Each dwelling was orientated North-West to South-East, with large glazed elements facing towards the South-East. Each dwelling has a sunspace designed to act as a thermal buffer in winter and to induce the **stack effect** in summer, to promote passive cooling. Windows are double glazed, argon-filled units.

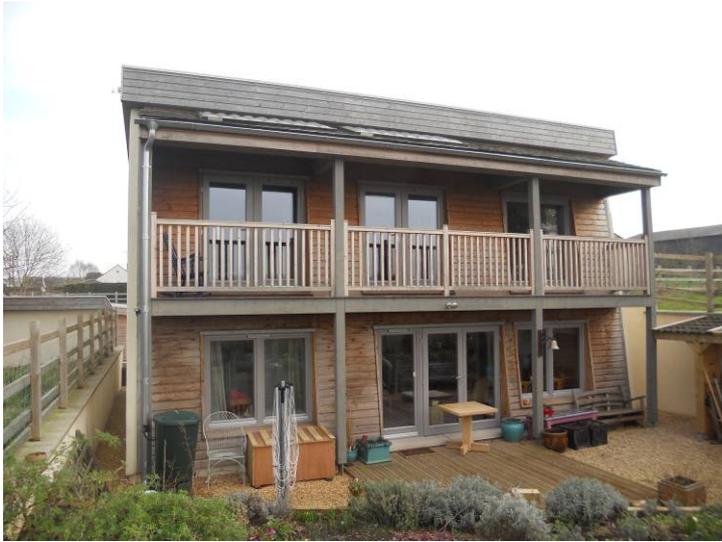
Figure 3. West elevation of monitored house

It is fitted with centralised **Mechanical Extract Ventilation (MEV)** to draw air continuously out of the house at a controlled rate. A passive solar strategy is used, with extensive glazing to the rear elevation protected from high summer sun angles by a large roof overhang and a first floor balcony. This glazing extends onto the living room/dining room and a small 'snug', both of which have hard tiled concrete floors to provide thermal mass storage and smooth passive solar gain to these spaces.

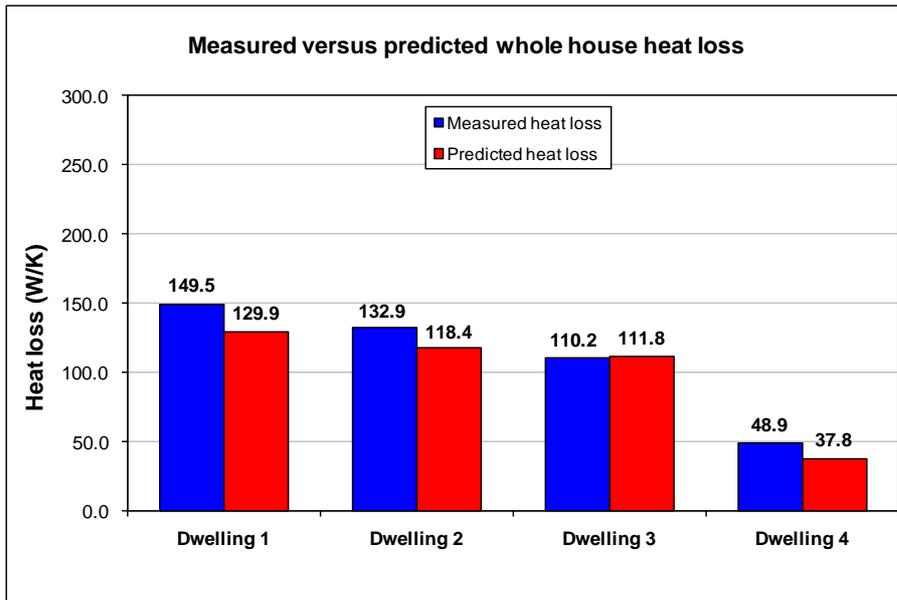
The results show a performance gap between the measured and predicted whole house heat loss for almost all of the dwellings, with the size of the gap varying somewhat.

Figure 4. A comparison between the total measured whole house heat loss and the predicted whole house heat loss of the GHA-tested dwellings [Johnston, D., 2011<sup>17</sup>]

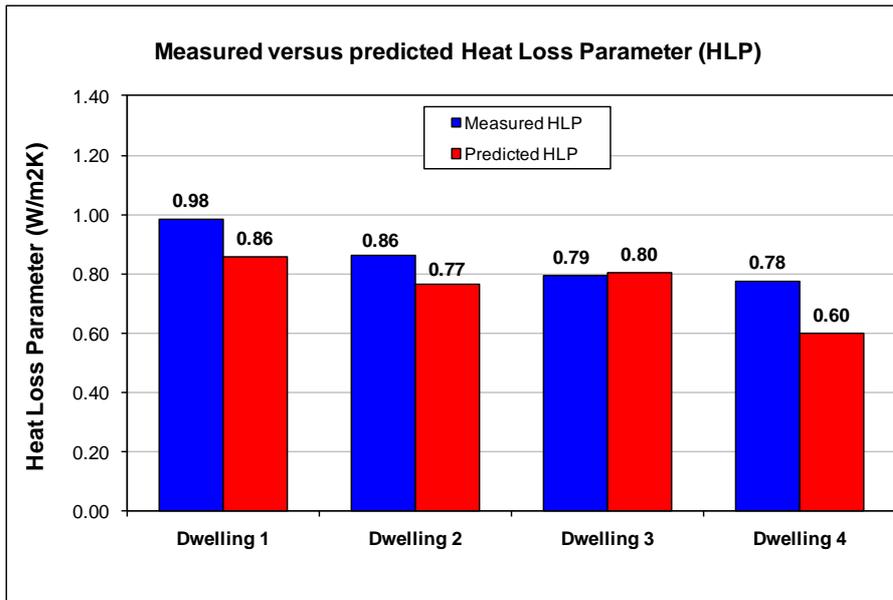
Figure 5. Measured versus Predicted Heat Loss Parameter for the GHA-tested dwellings. [Johnston, D., 2011<sup>17</sup>].

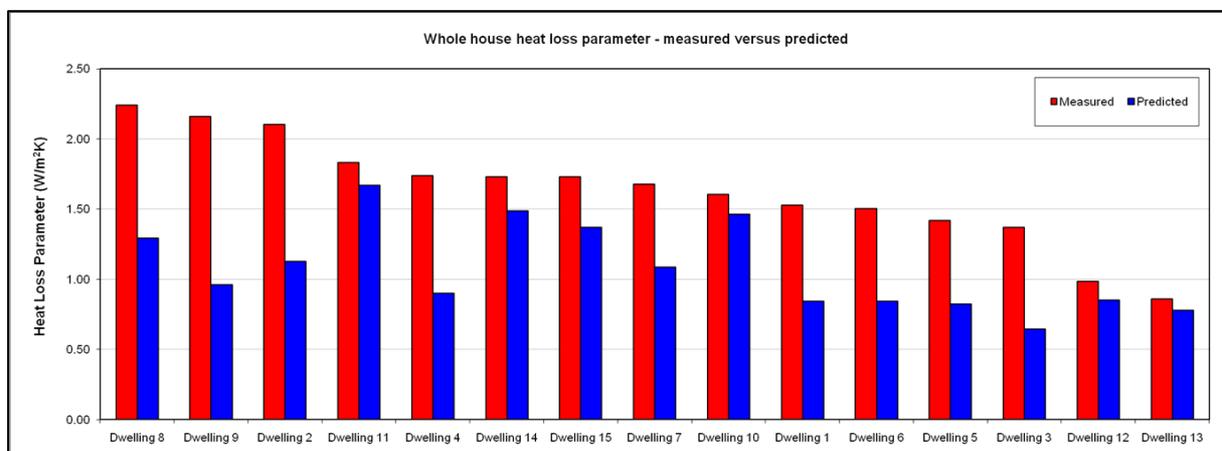
The results from the test properties are in line with research carried out by Bell et al<sup>7</sup> (see Figure 6). In their sample of 15 new homes built to various standards (including EcoHomes and the Code for Sustainable Homes levels, and under different Building Regulations), they found a gap between predicted and measured heat loss in the sample of homes they tested.

Figure 6. Difference in Whole House Heat loss, measured versus predicted. **Note GHA tested homes are not included.**

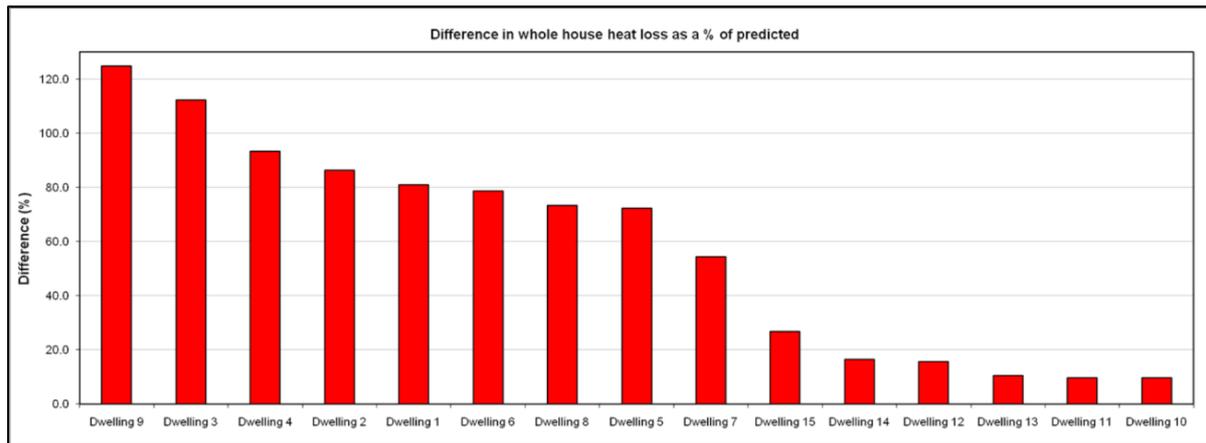
Thus, although a gap was identified in this programme, the percentage difference between predicted and measured performance of the GHA-tested homes was very good, i.e. low, when compared to the performance gap of the vast majority of the other tested homes. All of the GHA-tested homes had a gap between predicted and measured heat loss of less than 30%, whereas Bell et al reported that the gap between predicted and measured heat loss of the homes they tested can be over 100% (see Figure 7).

Figure 7. Difference in Whole House Heat loss as a % of predicted<sup>7</sup>. **Note GHA tested homes are not included.**
