GHA Monitoring Programme 2011-13: Technical Report

One Brighton

Results from Phase 2: Post-occupation testing of sustainable new homes

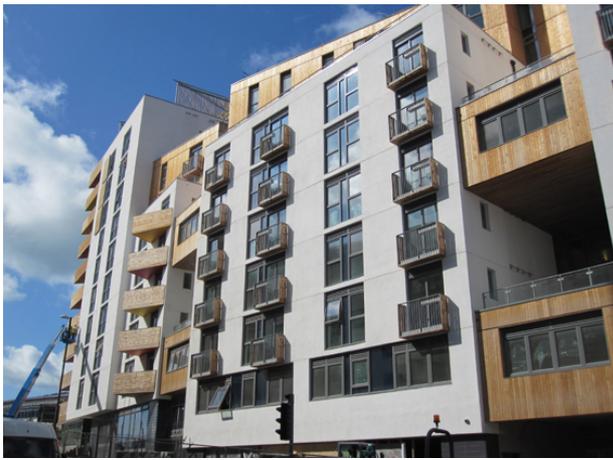
Figure 1. One Brighton

The apartment being monitored is situated on an intermediate floor of the Brighton Belle block at One Brighton (Figure 1). The apartment has a surface area of 45.84m^2 , consisting of a hallway, one bedroom, a bathroom and living room area comprising an open kitchen, a small dining space and lounge. The living room area has a floor area of 21.14m^2 and the apartment a floor to ceiling height of 2.65m. The apartment is North-West orientated and has 9.24m^2 of exposed external wall and 5.88m^2 of windows (including a glass door in the living room for access to a small balcony). The apartment is occupied by a woman in her 30s, who is out most of the day as she works in another city.

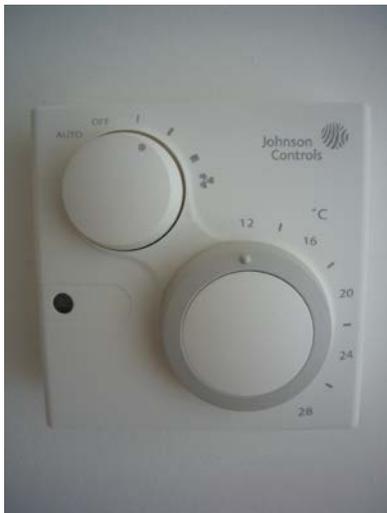
Figure 7. FX07 MVHR control

Even though there is no record of an official commissioning of the MVHR at One Brighton, a spot check was carried out. Measurements were taken using a TSI Aircone Flow Hood. Three readings in the highest speed as given by the control (Figure 7), which is not boost mode, were taken per supply and extract terminals and the average calculated. Flow rates recommended for commissioning of the MVHR at its highest speed setting (76 l/s) are presented in Table 2. As can be seen in Table 3, the ventilation flow rates measured for supply are higher than those measured in the extracts (more air is being supplied than extracted). It was also found that the ventilation rates measured are significantly lower than the recommended commissioning value, reaching almost 60% lower rates than recommended commissioning values.

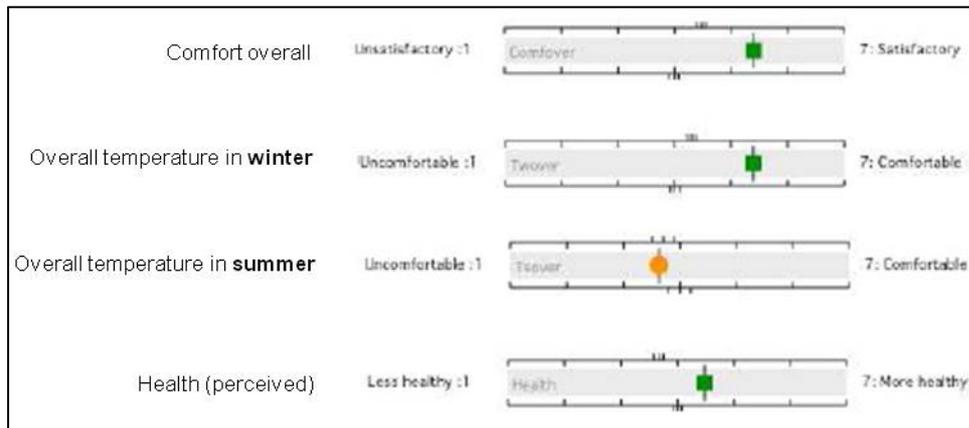
The results from the BUS indicate that according to occupants’ opinions, One Brighton delivers healthy and satisfactory living conditions in 70 to 80% of apartments. 82% of

Figure 10. General results of the BUS survey carried out in January 2011
