Air tightness and health

Primary air barrier— Design it with CARE

UrbanBuzz Project—Developing Low Carbon Housing: Lessons from The Field—LowCarb4Real

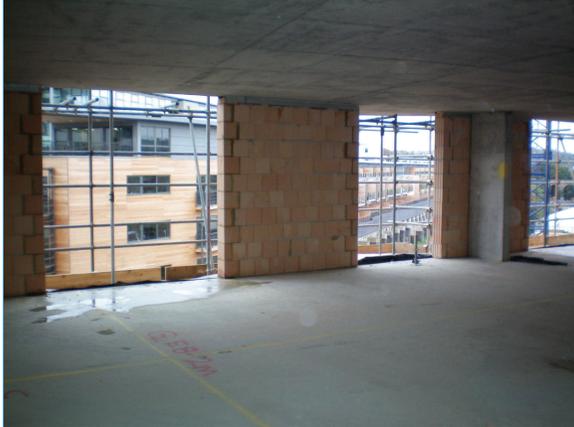
One Brighton is being built under a design and build contract. The thermal efficiency and airtightness targets of 5 m³/h/m²@50 Pa were set by the developers as part of the extensive sustainability action plan for the site.

The construction is a lean concrete frame, with a single skin infill wall from Thermoplan blocks. These monolithic blocks are extruded with vertical perforations.

Continuous The primary air tightness barrier is provided by the internal parging coat on the

Thermoplan blocks.

In addition, the frame and infill blocks are wrapped externally with insulation of compressed interlocking T&G 100mm wood-fibre boards and rendered or clad.

Accessible: Sequencing was changed to ensure that all areas to be parged are accessible—to prevent discontinuity.
Robust: The parged coat gives a robust and long lasting air tightness.

Explicit: The importance of the continuity of this parging layer has been emphasised to site staff and a first test has been completed and reported and a check list compiled of areas that require particular attention.

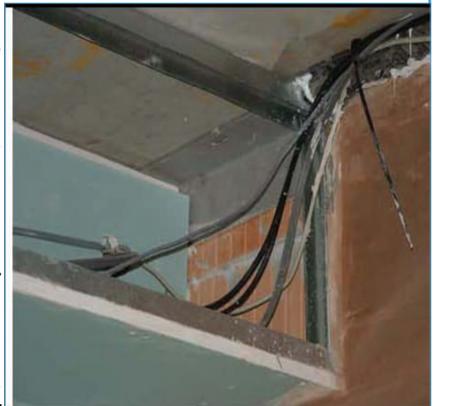
Leakage where section of external wall within services boxing remains unplastered.

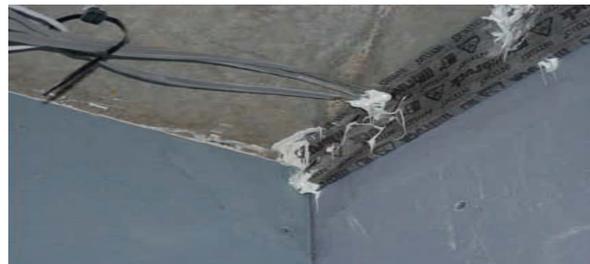
Leakage where membrane is poorly sealed around cables—use of grommets was recommended

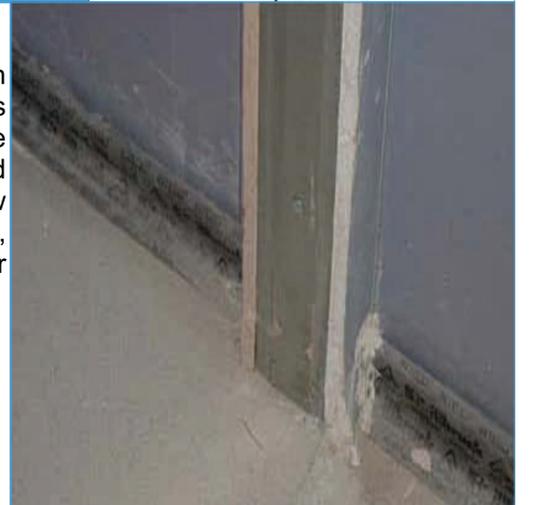
Crack leakage beneath bottom of door frame where membrane seal along base of plaster board is discontinuous.

- utilising a more robust membrane system and ensuring that it is fully adhered and properly overlapped at joints, and is mechanically trapped behind plaster(board) or other elements wherever possible;
- Ensuring that any foam sealing is cut back and sealed over with mastic to ensure the most effective seal;
- Cleaning all surfaces, particularly at low level, to remove dust before mastic or sealant is applied, and ensuring that all mastic joints are tooled in place to give a good finish and the best possible adhesion;
- Providing a continuous mastic seal around all window and door frames, including between the slab and the plywood cill, and extending this to include all vertical joints in the boxing in found adjacent to window and door openings. We estimate that Air Permeability values of as low as 1.0 (m³/hr/m² @ 50 Pa) should be achievable.
