Good Homes Alliance Monitoring Programme 2009-11: Technical Report

Results from Phase 1: Post-construction testing of a sample of highly sustainable new homes

**Results from Phase 1: post-construction
performance of a sample of highly sustainable
new homes**

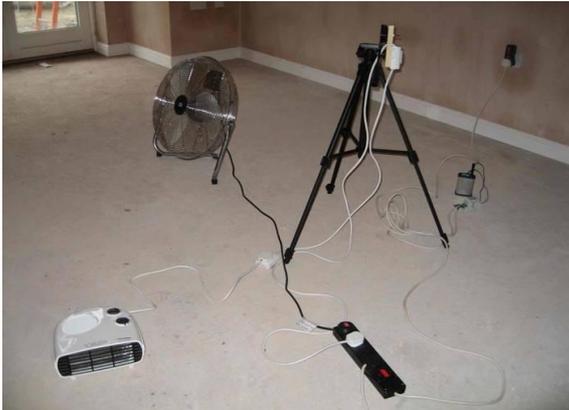
The co-heating test is designed only to measure the heat loss through the fabric of a building. Although a background ventilation test is conducted immediately before and after the co-heating test, this is done simply to eliminate the natural background ventilation heat loss from the dwelling, so that this can be separated from the fabric heat loss.

Figure 1: Co-heating test equipment; photograph courtesy Leeds Metropolitan University

The co-heating utilises a tracer gas decay method to confirm the background ventilation rate during the period of the co-heating test. In this, a gas (usually CO₂) is dispensed into the sealed building once daily, and sensors around the dwelling measure the gas concentration over time to determine the amount of gas that has leaked out. Further details of the methodology for co-heating tests are available at Wingfield et al.¹¹

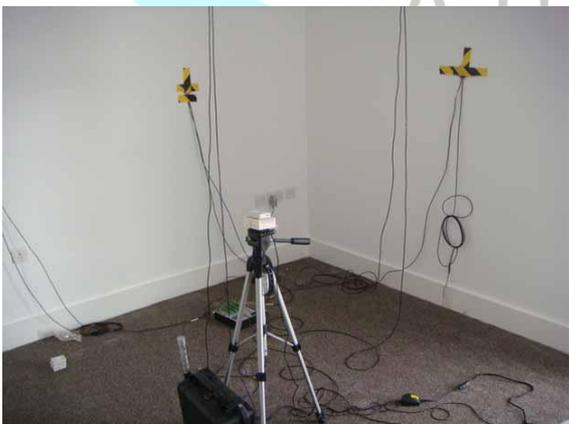
The insulation performance of solid elements, such as a wall or a roof, can be measured using local heat flux sensors (see figure 7 below); these measure direct heat flow through various elements of the building fabric. The measurements are used to determine an effective average U-value for each element concerned, and the information can be used to help identify any areas of heat loss from a dwelling.

Figure 2: Heat flux sensors; photograph courtesy University College London
